**MINERALS MANAGEMENT SERVICE**

**HURRICANE ANDREW  
PLATFORM INSPECTION AND ANALYSIS**

**FINAL REPORT**

**PMB ENGINEERING INC.  
SAN FRANCISCO, CALIFORNIA**

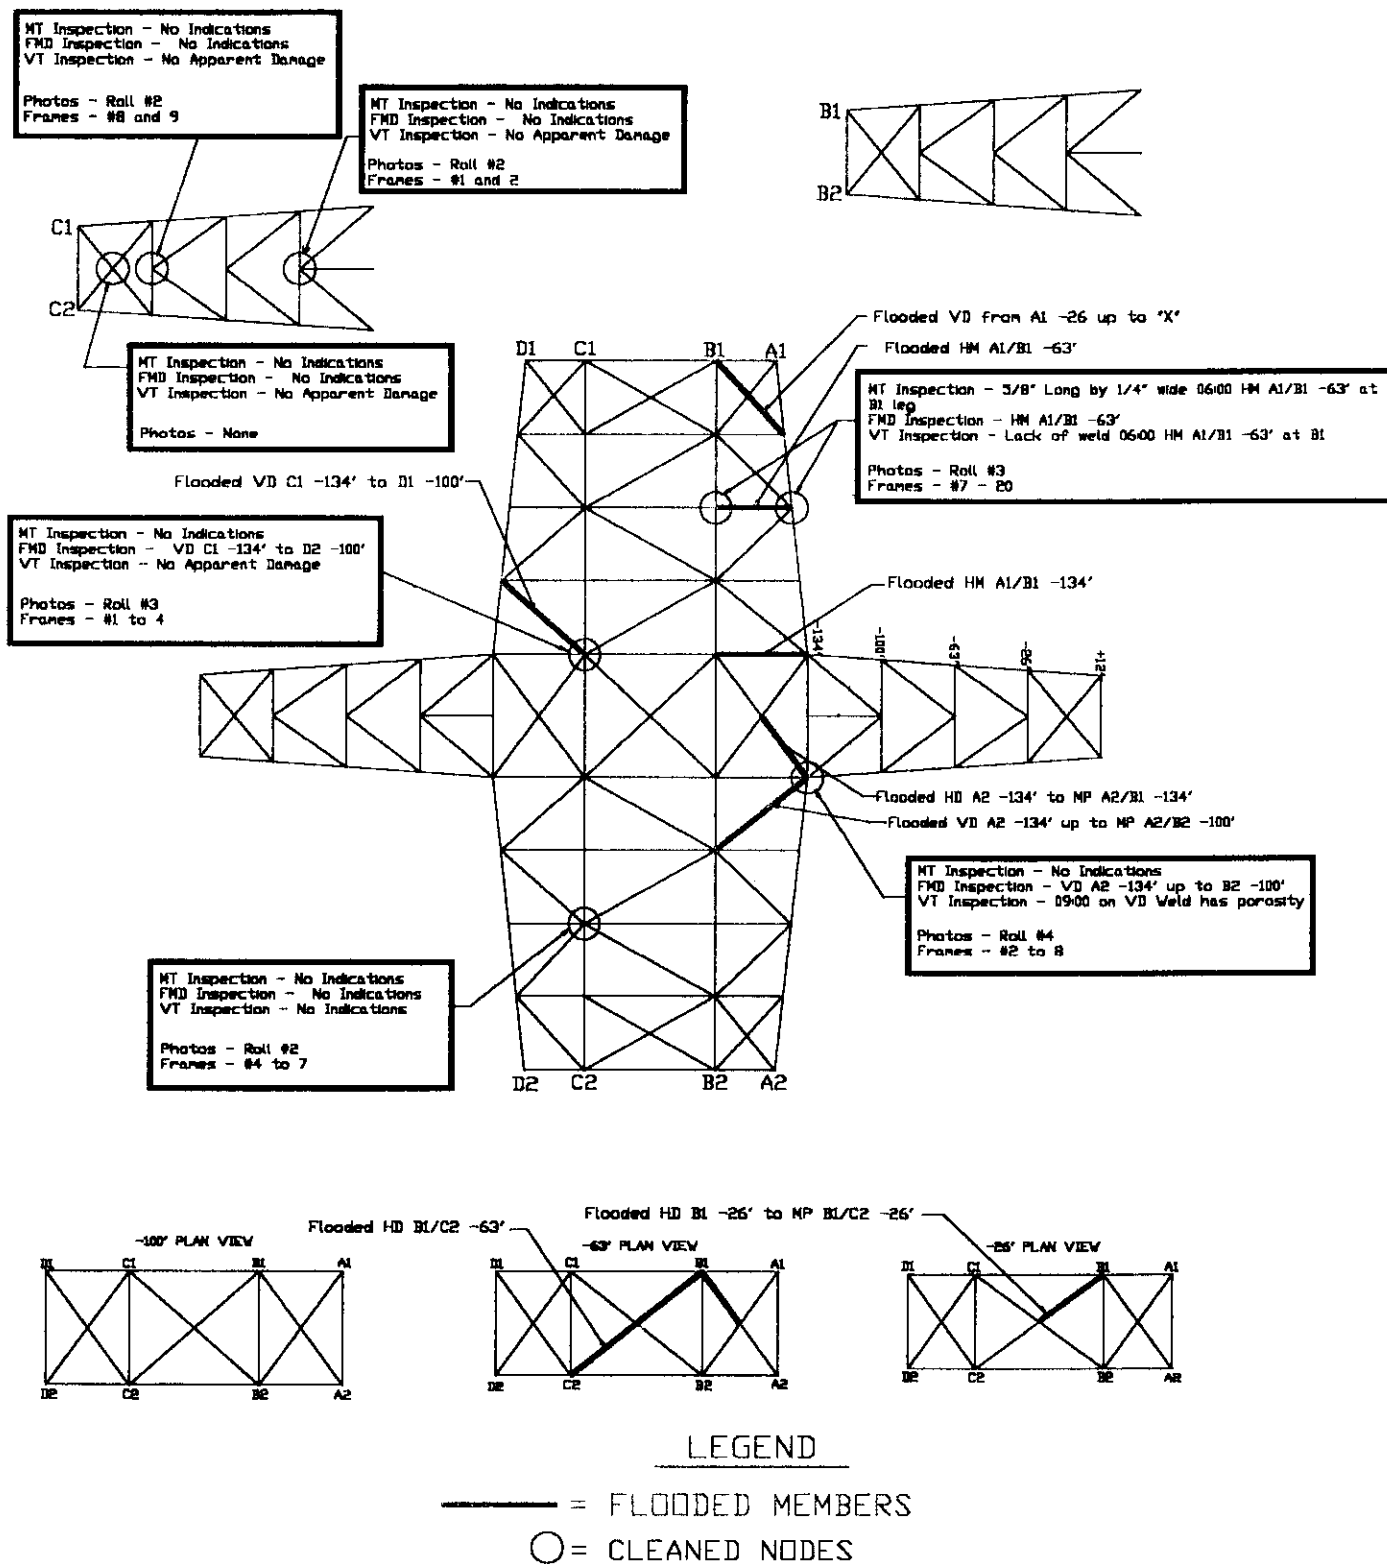
**Figure 2-5 Platform ST 151 K - Inspection Results**

INSPECTION NO. 93/072	CLIENT PMB	INSPECTION RESULTS SUMMARY	DWG. NO. ST151K (FIG 1)
DATE 11/16/93	STRUCTURE ST-151-K	ST-151-K	OCEANEERING

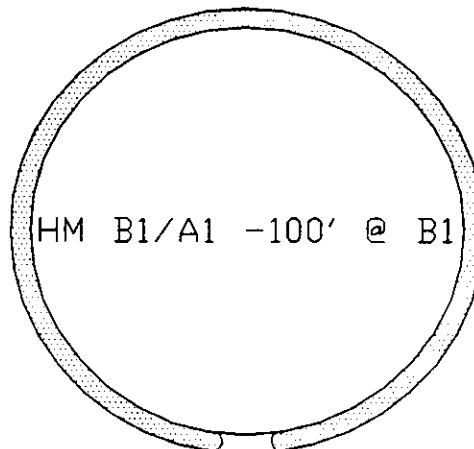
Figure 2-6 Platform ST 151 K - Missing Weld Material

LEG B1

Area where there is Lack of weld metal  
5/8" Long by 1/4" Wide

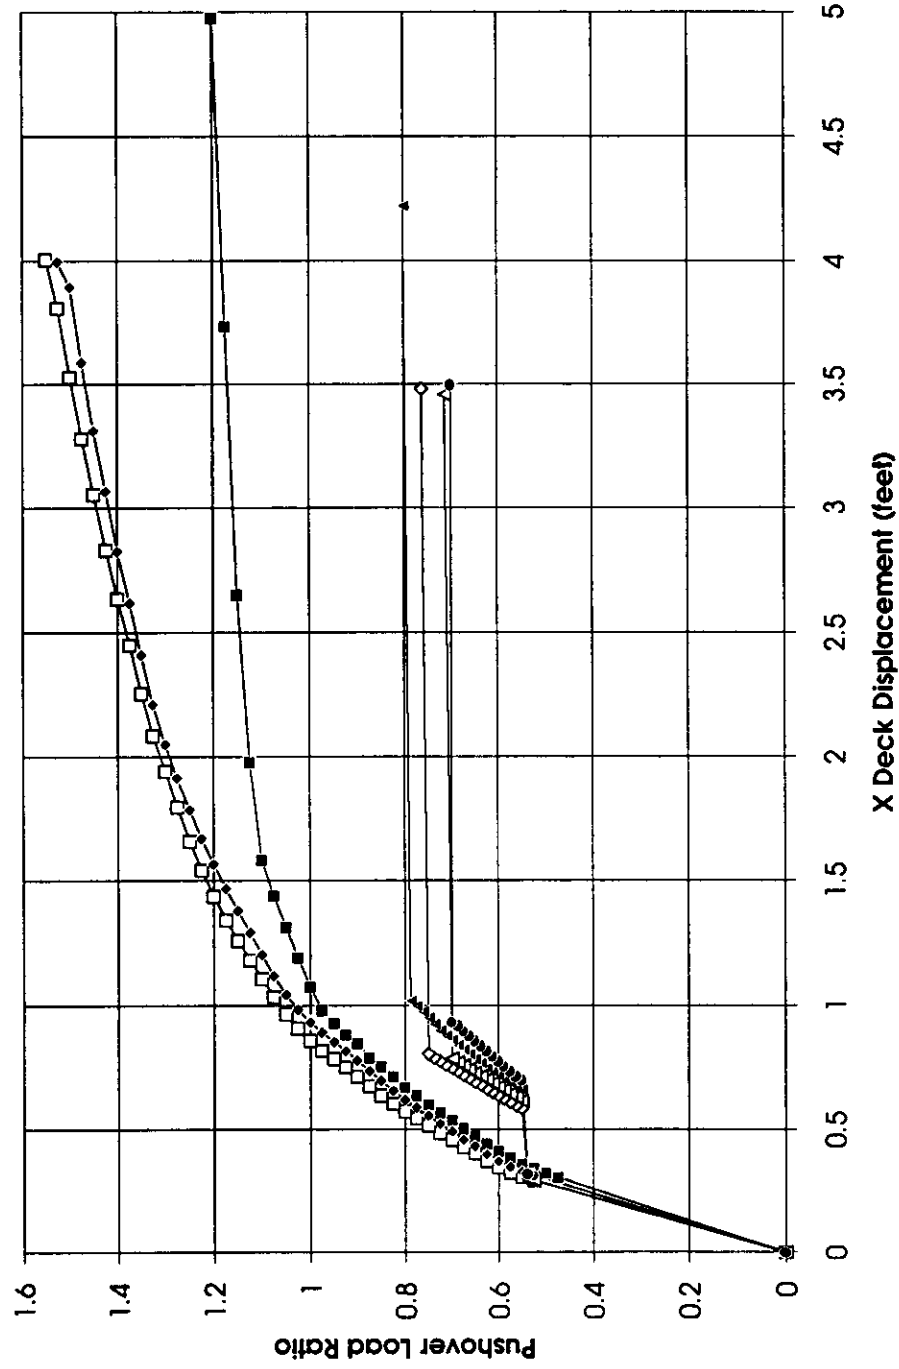
**Figure 4-3 ST 130 A Results Comparison**

A summary plot of the pushover load ratio as a function of deck X-direction lateral displacement for all major analyses is shown in Figure 4-3. In this figure, the following abbreviations are used to identify the analyses: DF = double foundation strength, WL = weak leg section, BB = brittle K-braces (but not joints), BJ = brittle K-joints. These results will be discussed in the following sections.

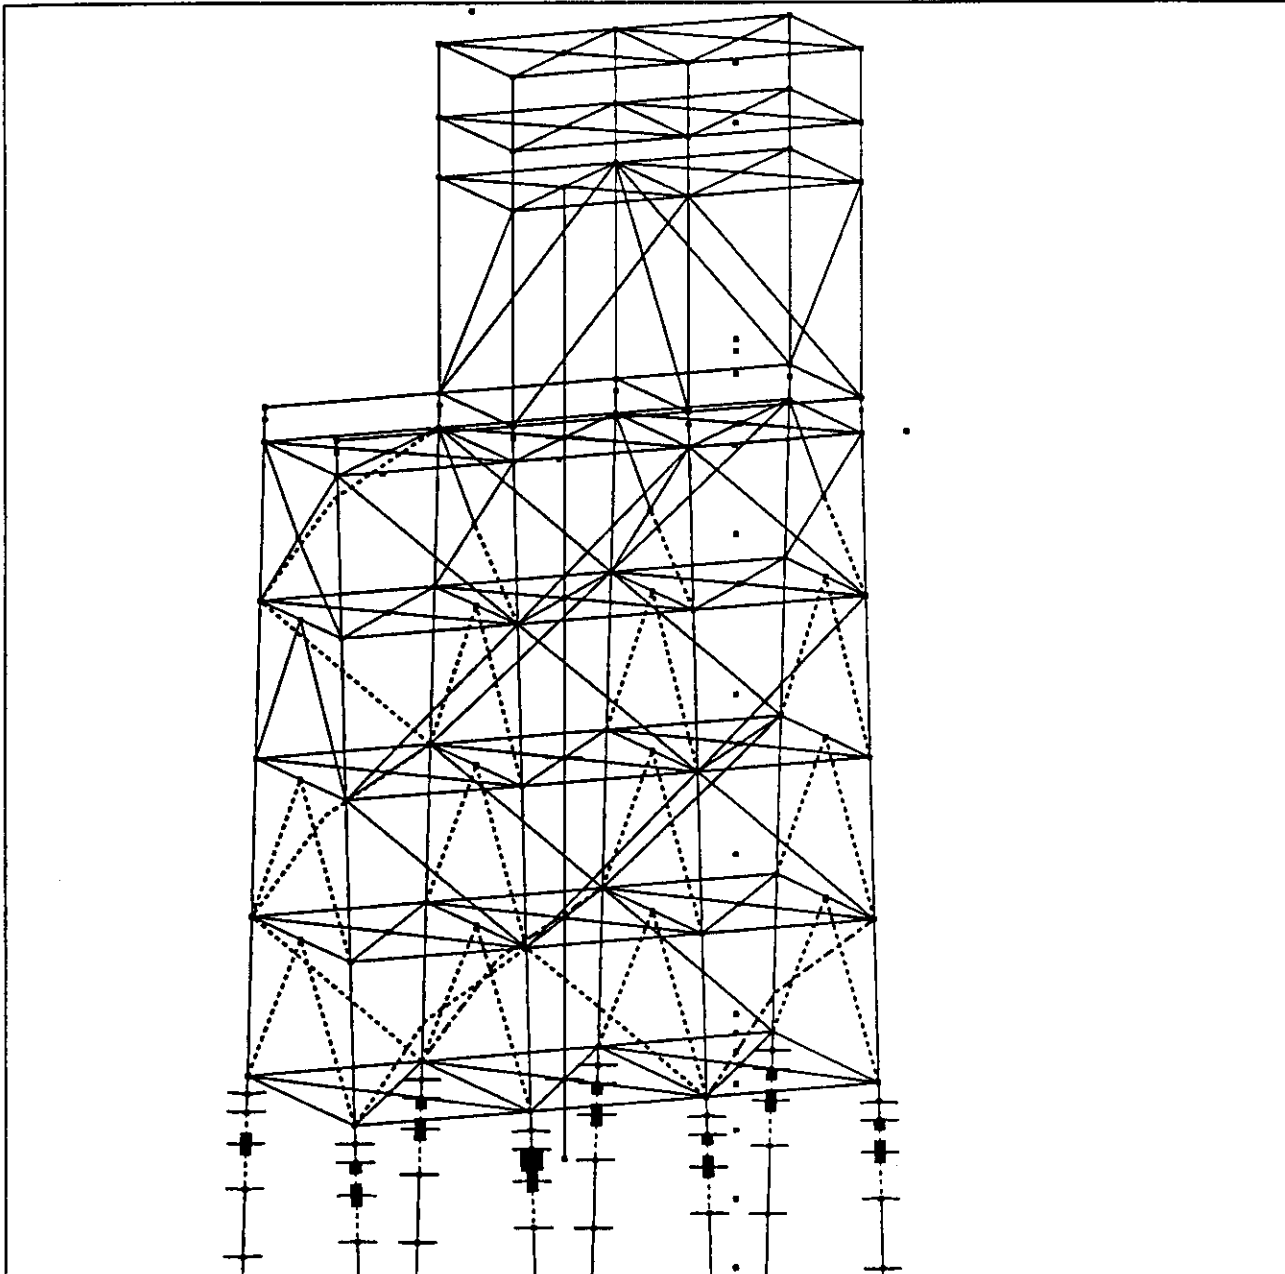
**Figure 4-4 Basic Model Failed Components**

The capacity of the basic model is 1.20 times the Hurricane Andrew environmental pushover load. The yielded and failed elements at the time of the last load step are indicated in the plot in Figure 4-4. This analysis terminated due to large displacements before all the piles had become plastic, but it is clear from the detailed results that the platform's global failure would be caused by lateral pile failure. At this time, no platform legs have yielded, though nearly all

the transverse K-braces have failed (dashed lines in Figure 4-4).

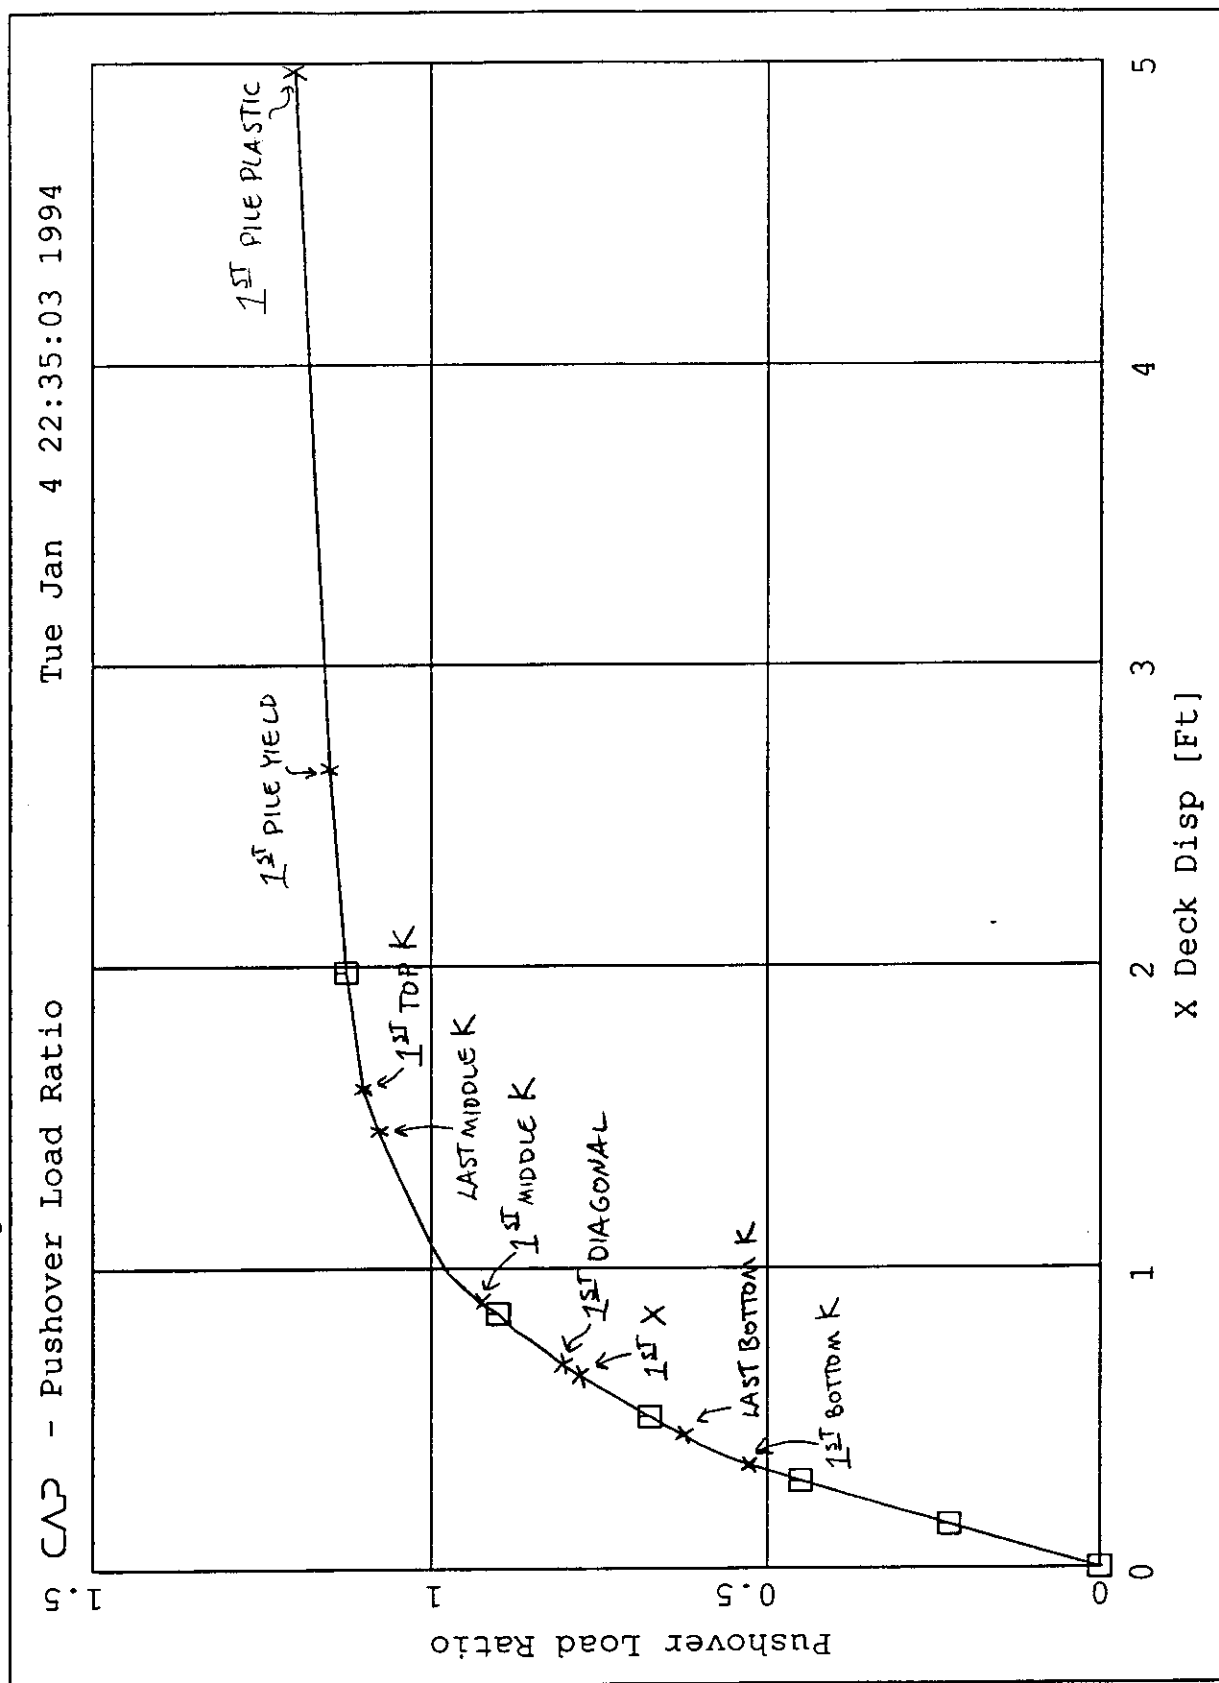
**Figure 4-5 Basic Model Results**

The pushover load ratio plot is shown in Figure 4-5, with major events indicated. The general behavior is that of a gradually, smoothly, decreasing stiffness, with no abrupt changes in behavior until final failure. The first elements to fail are the bottom K-braces, which begin failing at 0.525 times the load ratio.

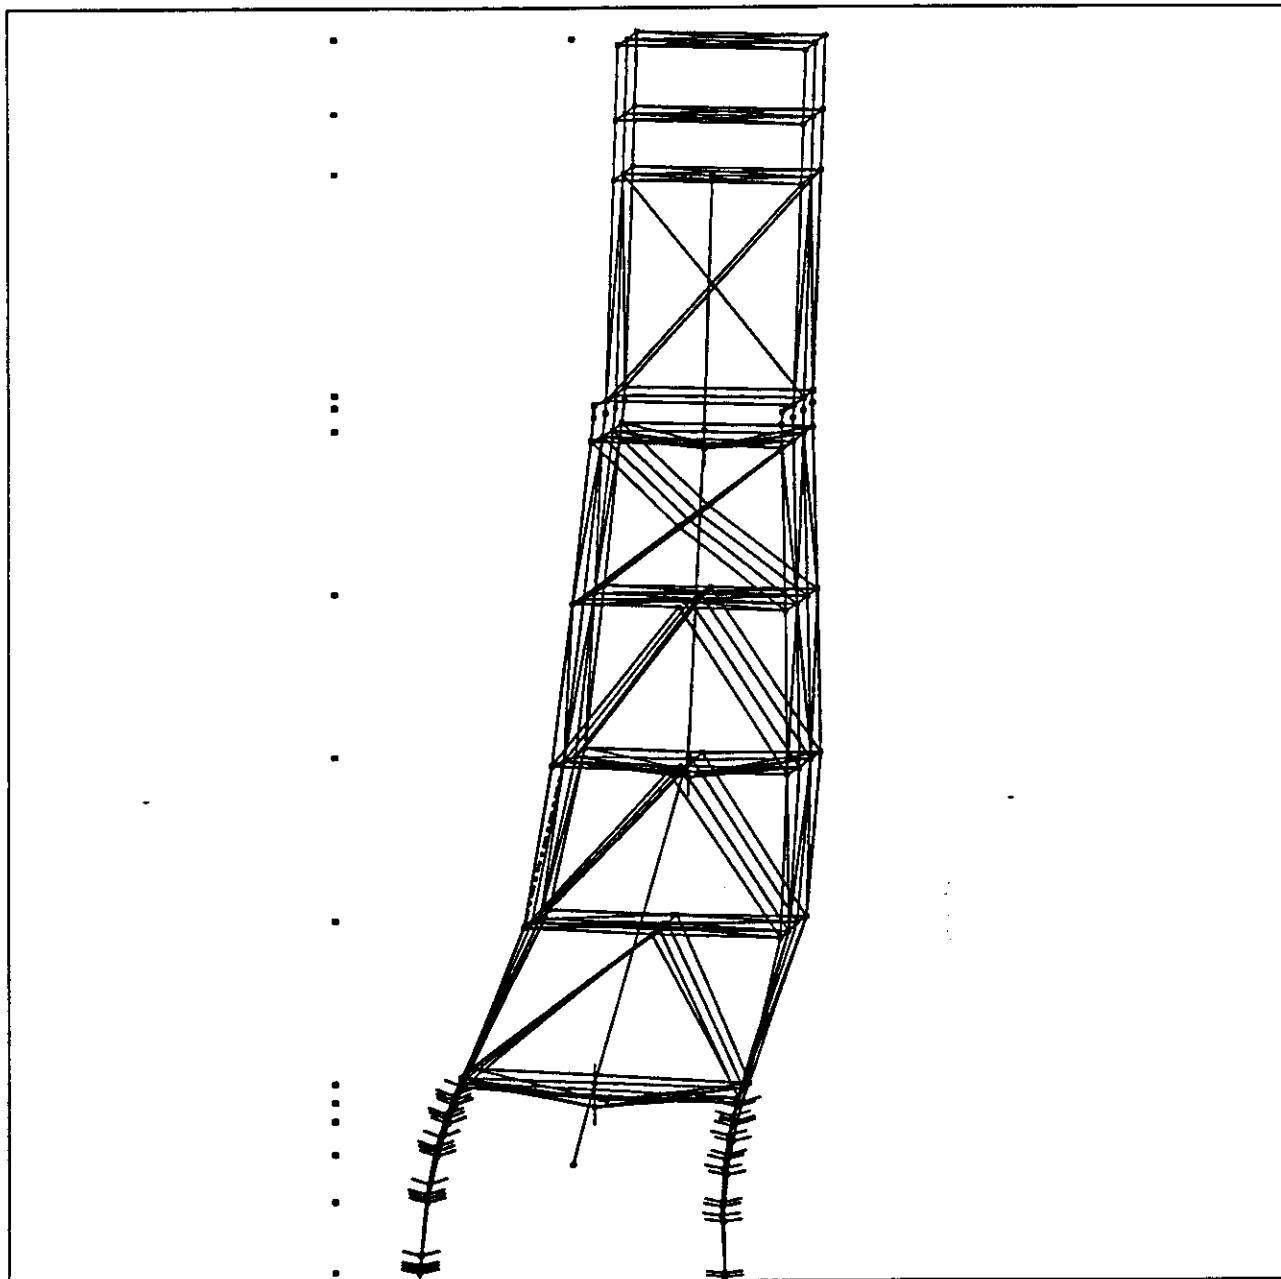
**Figure 4-6 Basic Model: Load Ratio = 1.100**

Sample displaced shape plots are shown in Figures 4-6 and 4-7. Figure 4-6 occurs at a load ratio of 1.1. Note that the lowest bay has experienced far more shear deformation than the rest of the platform, as all K-braces in this bay have failed by this time. Note also that a significant portion of the deck displacement is due to pile deformation. Figure 4-7 shows the structure even later, at a load ratio of 1.175 (shortly before global failure). In this plot, the deformation of the piles is even more pronounced.

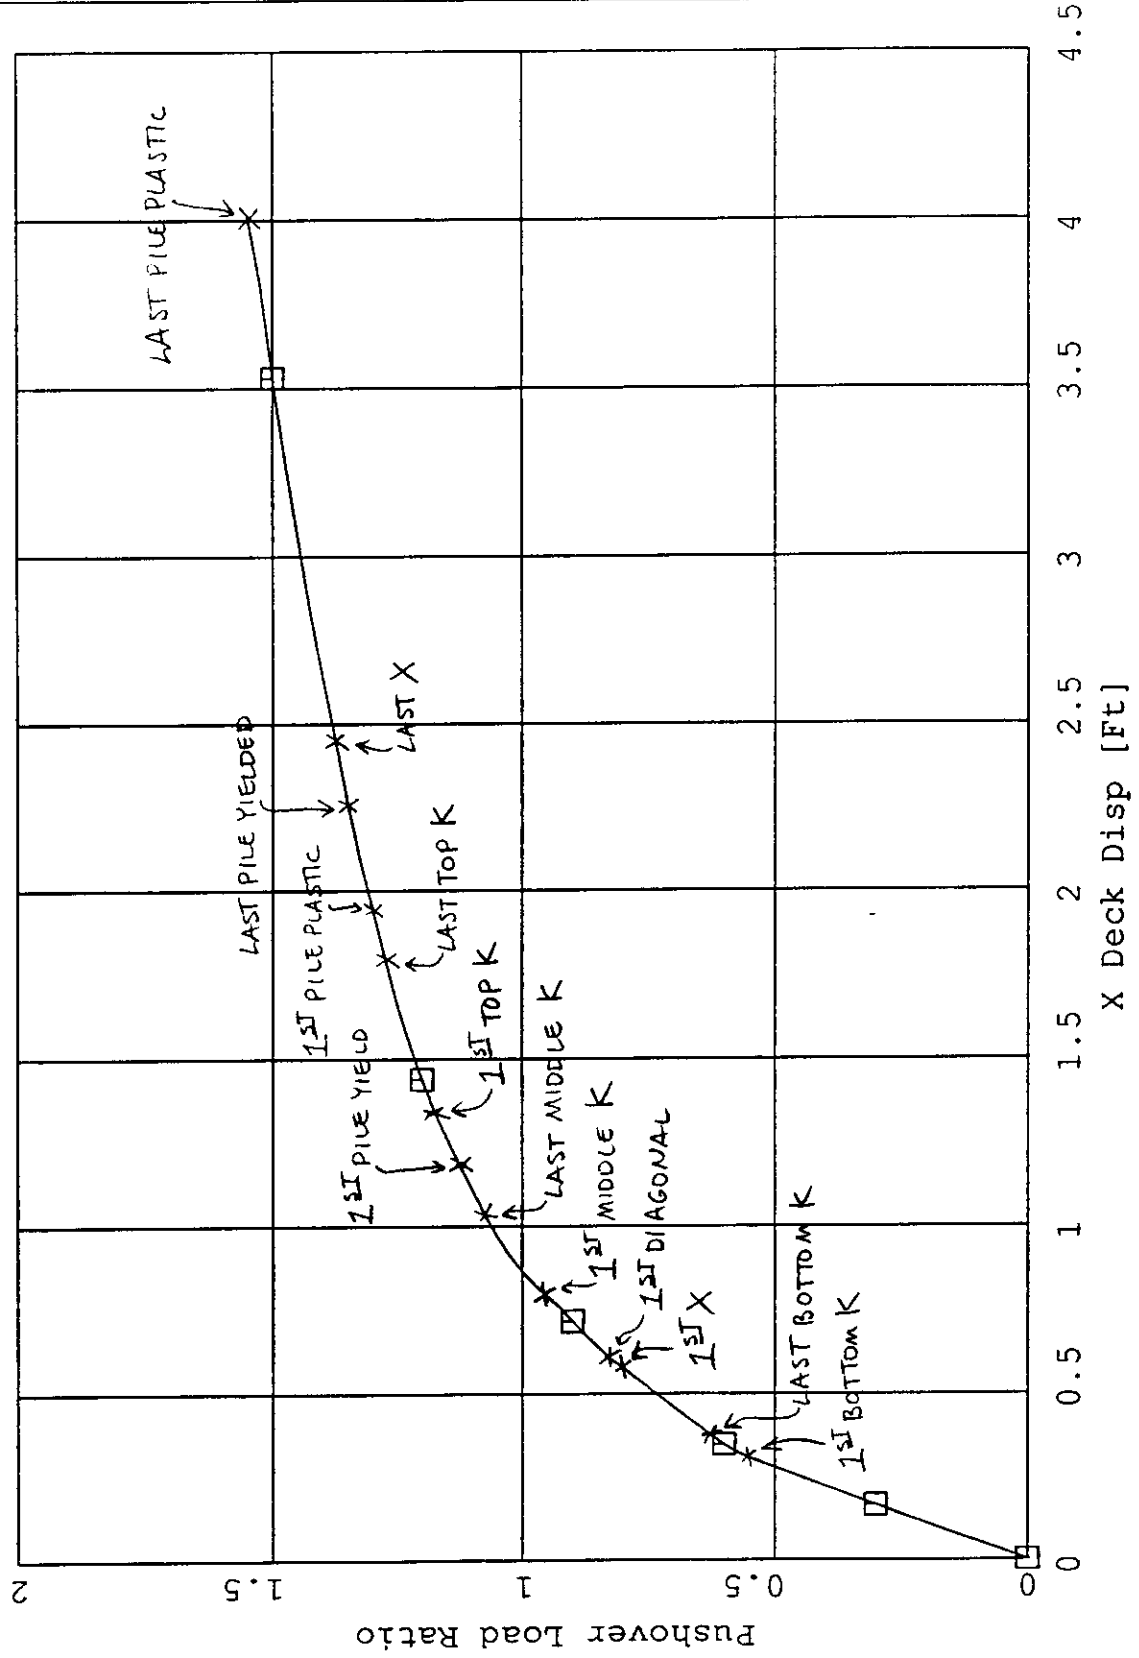
Figure 4-9 Increased Foundation Strength Results

The pushover load ratio plot is shown in Figure 4-9, with major events indicated. The behavior is similar to that of the base case, except that, as expected, it is slightly stiffer for equivalent load ratios and global failure occurs later. The first elements to fail are still the bottom K-braces, at virtually the same load ratio as before.

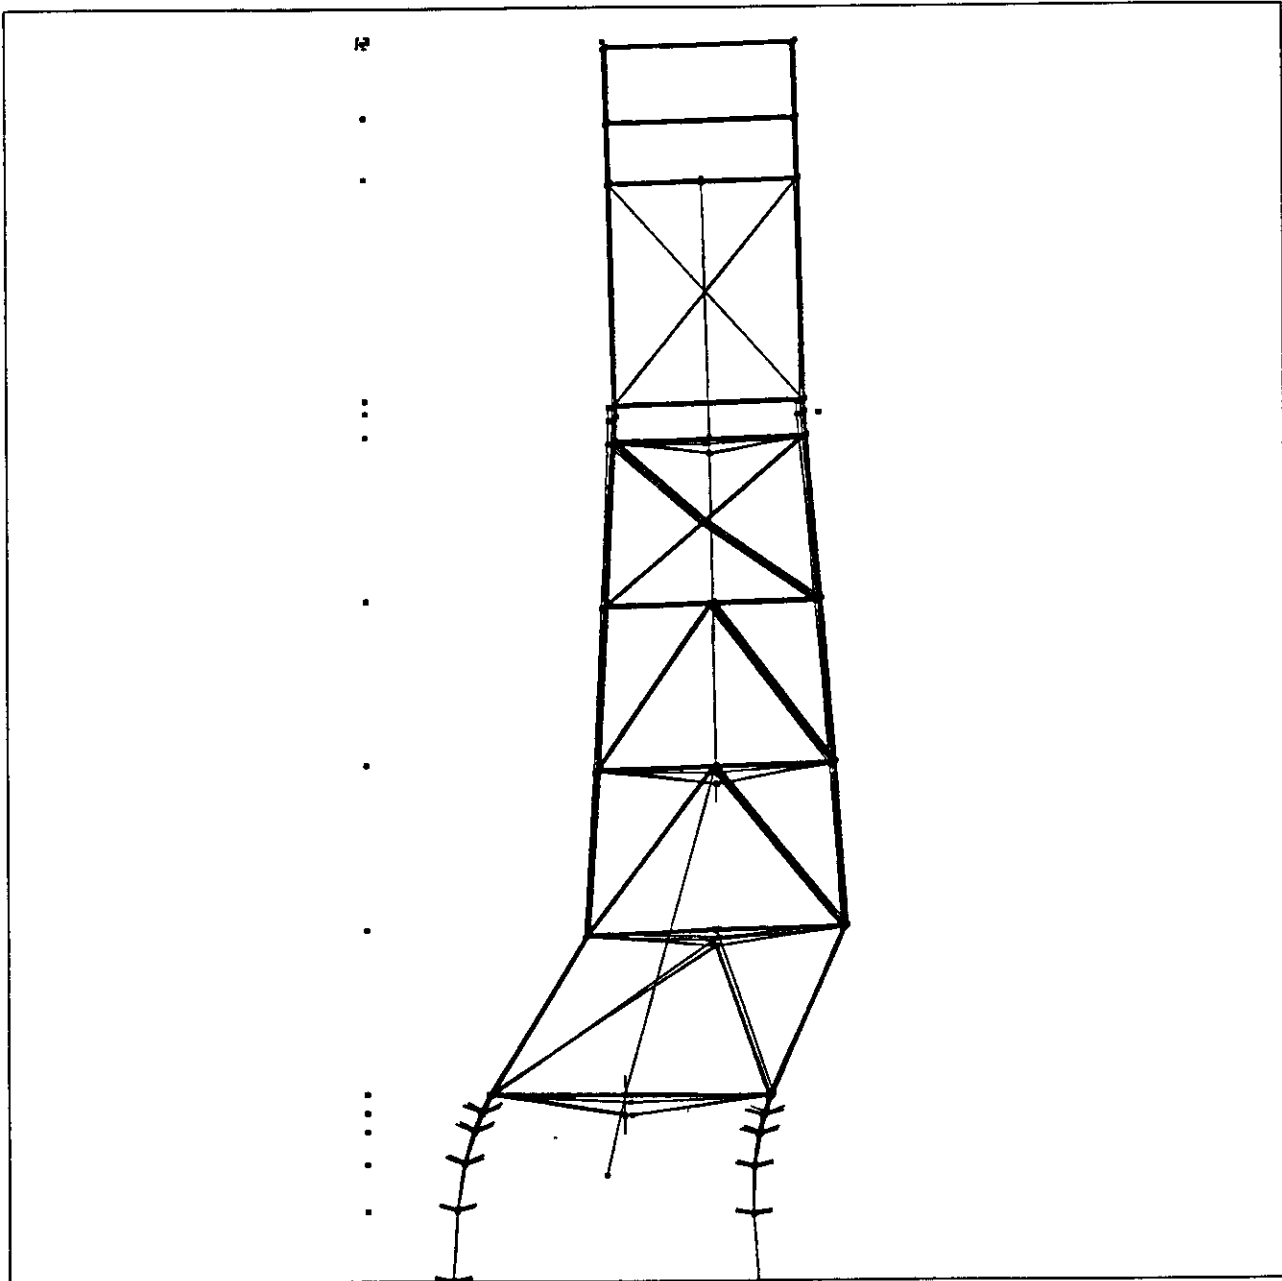
**Figure 4-22 Brittle Brace Weak Leg Shape Near Collapse**

The displaced shape at the next-to-last load step is shown in Figure 4-22. The deformation of the bottom bay is even more pronounced compared with the rest of the structure than in the previous non-brittle analyses, because the stiffness of the bottom bay is reduced when the K-braces shed all their load. Note that physical examination of the failed platform also indicated complete failure of the k joints and legs in this region, as described in Section 2.2.

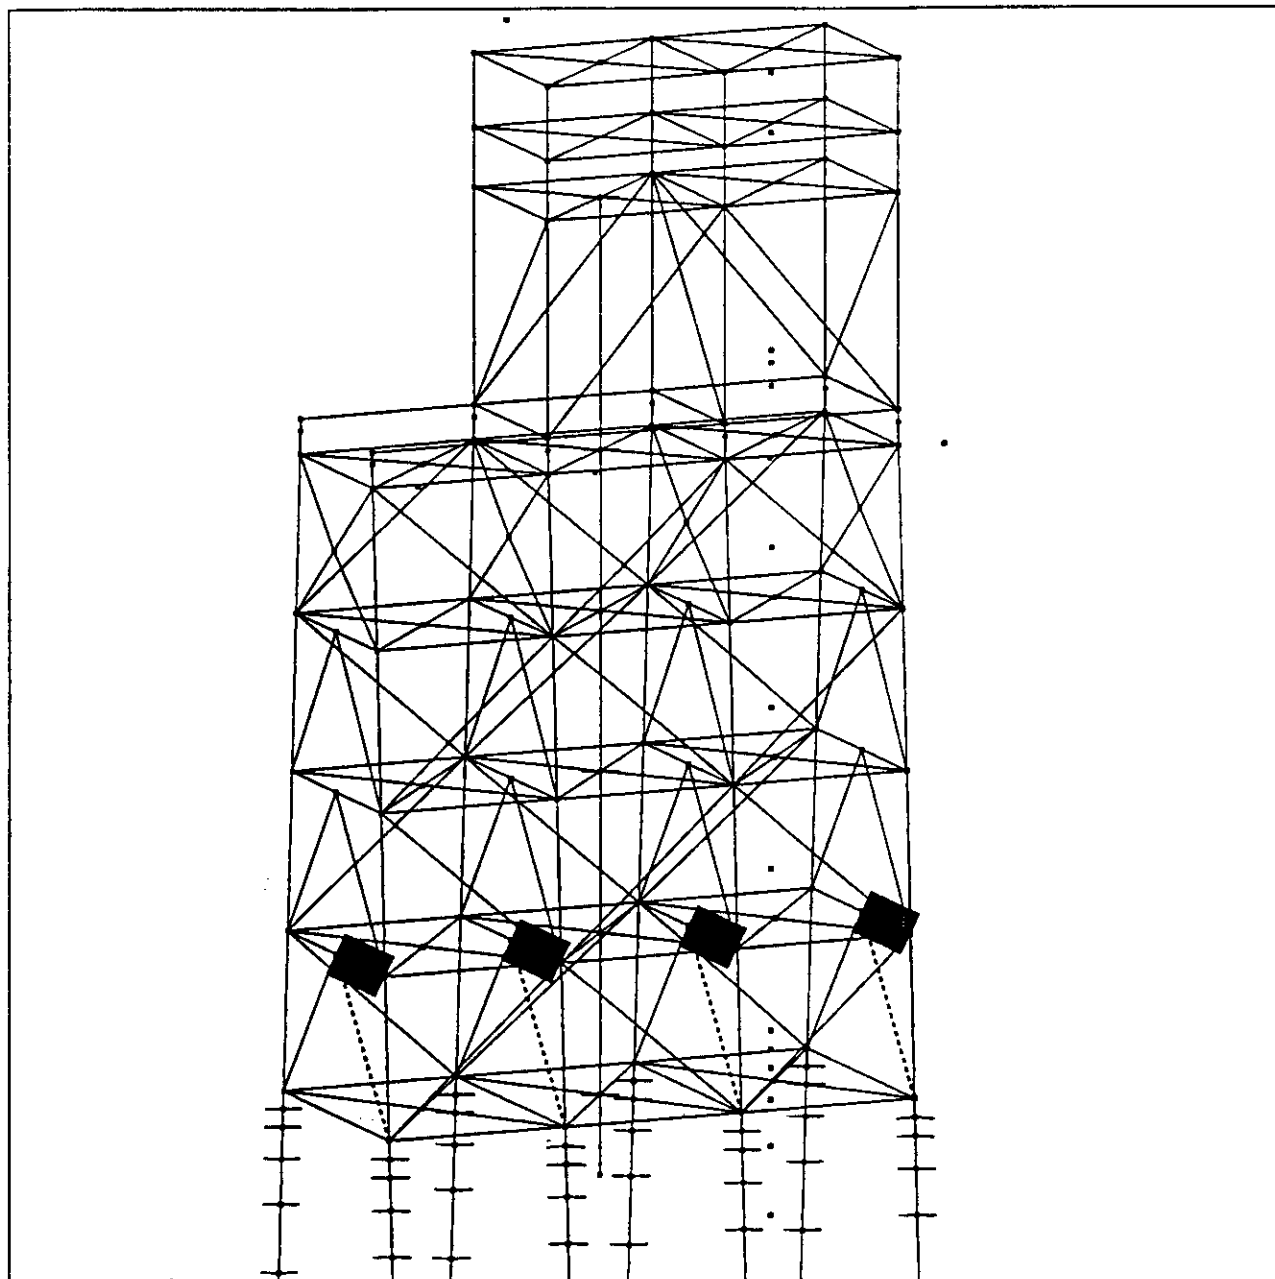
**Figure 4-23 Brittle Joint Model Failed Components**

The capacity of the brittle K-joint model is 0.71 times the Hurricane Andrew environmental pushover load. Brittle failure of the chords of the K-joints thus decreases the platform's capacity by about 7%. As in all previous analyses, the bottom K-joints were the first part of the structure to fail, as shown in Figure 4-23. This figure shows the failed components at a pushover load ratio of 0.55, which, as in all previous analyses, is when the K-joints failed. All of the failed elements in this plot have failed in a brittle fashion.

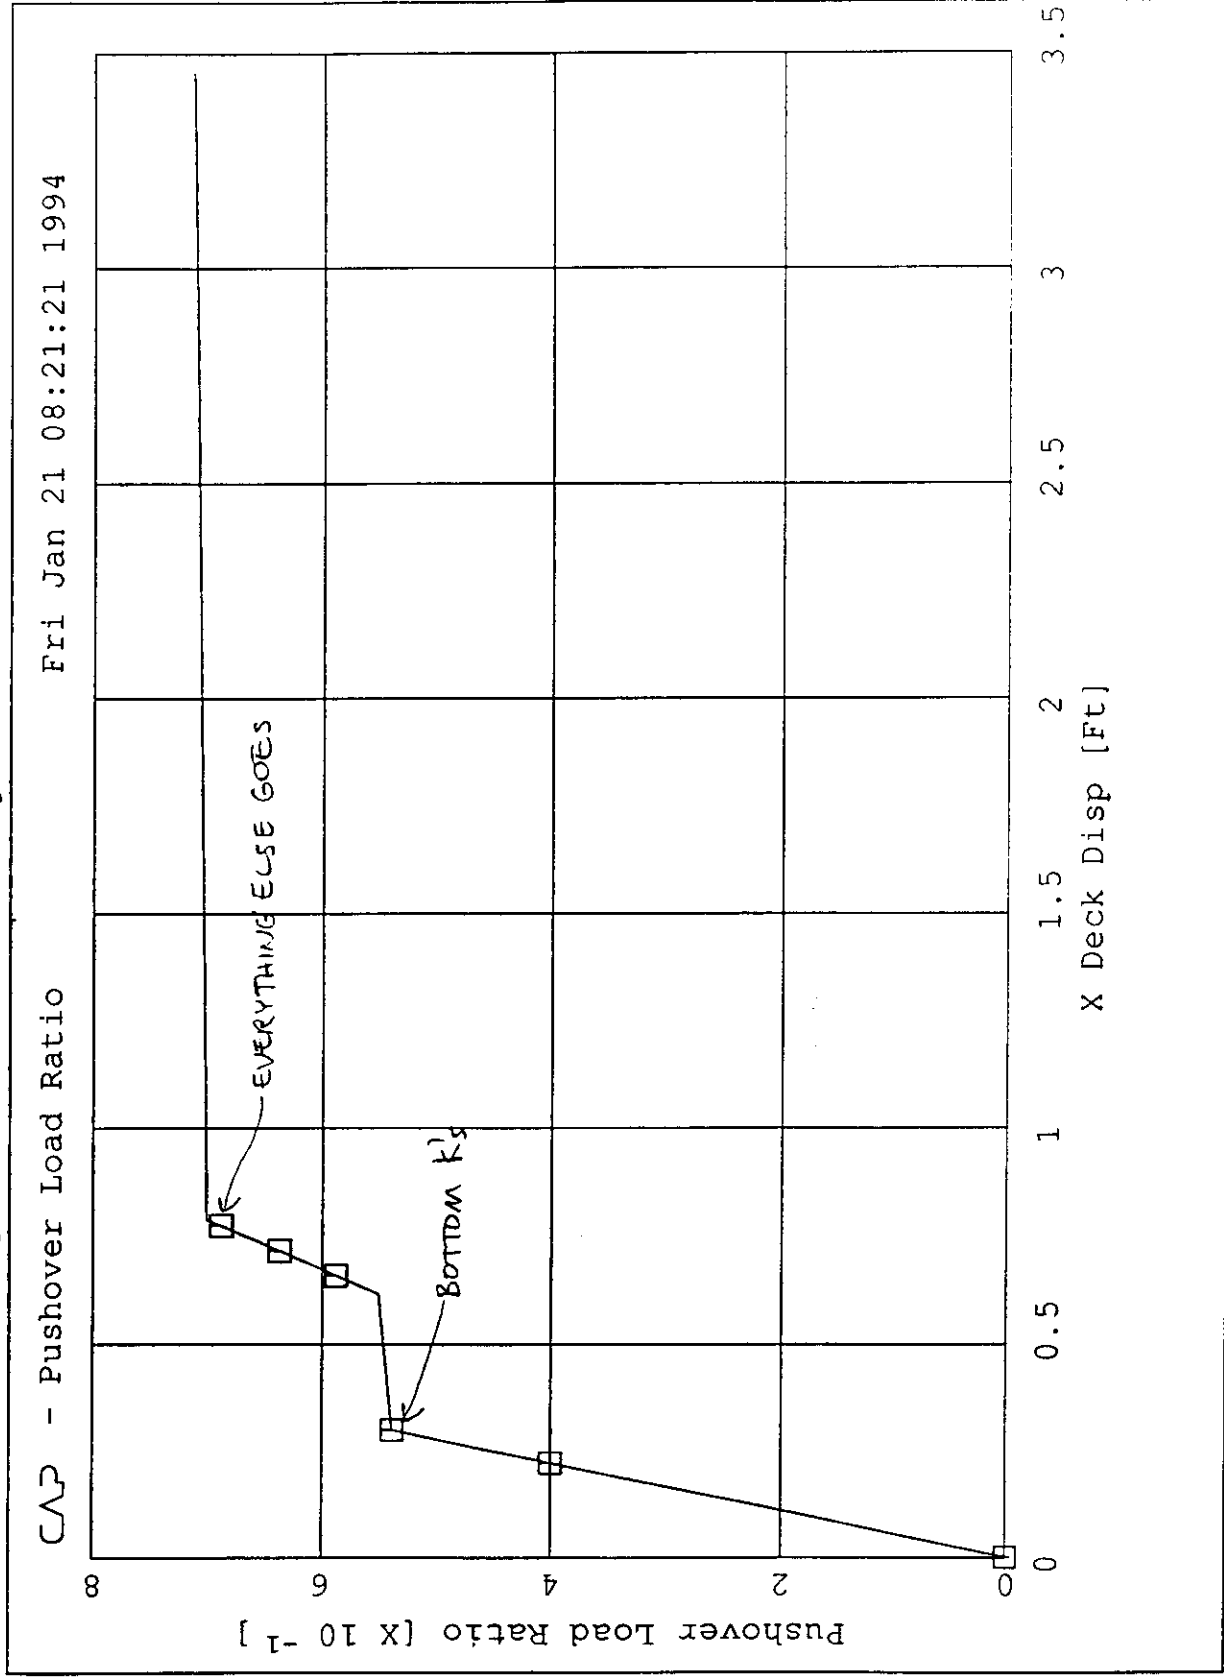
Figure 4-25 Brittle Joint Model Results - X Direction

The pushover load ratio plot is shown in Figure 4-25, with major events indicated. It is similar to the plot for the previous brittle brace (but not joint) analysis, except that the region of load increase between the bottom bay K-joint failure and the global failure is slightly shorter.

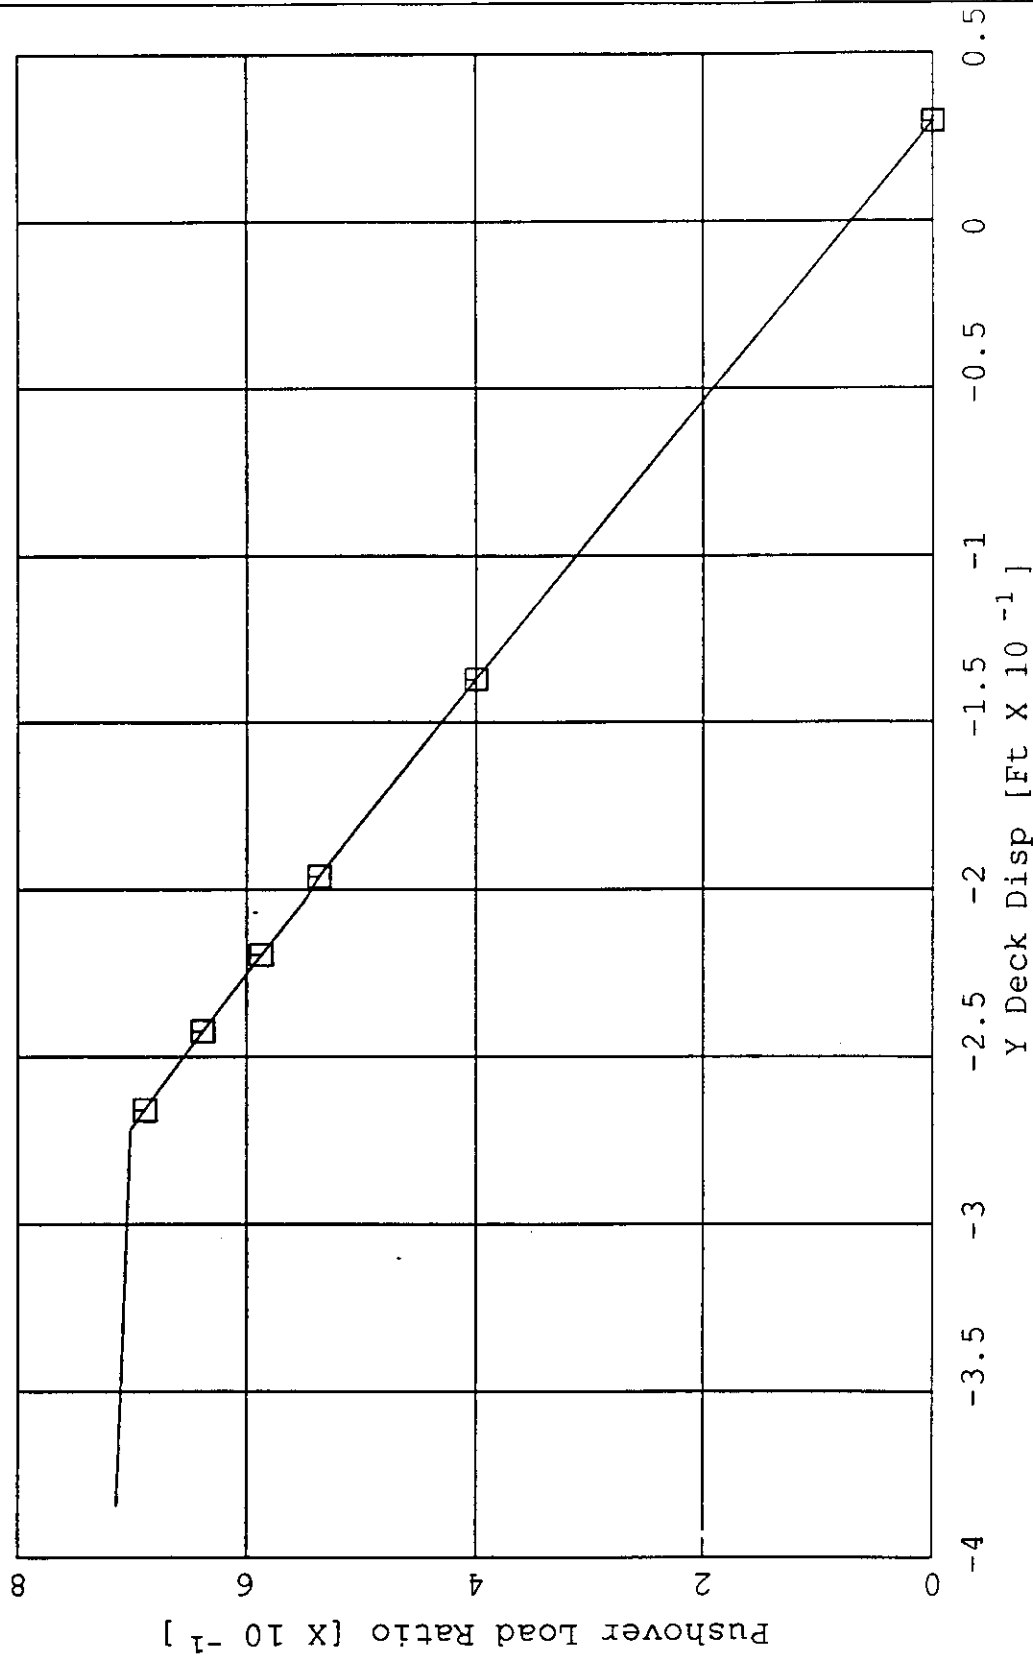
Figure 4-26 Brittle Joint Model Results - Y Direction

For comparison, the pushover load ratio plot for Y-direction (longitudinal) lateral displacement is shown in Figure 4-26. Because no braces in the longitudinal frames fail until global platform failure, the load/displacement behavior is linear until the very last step.

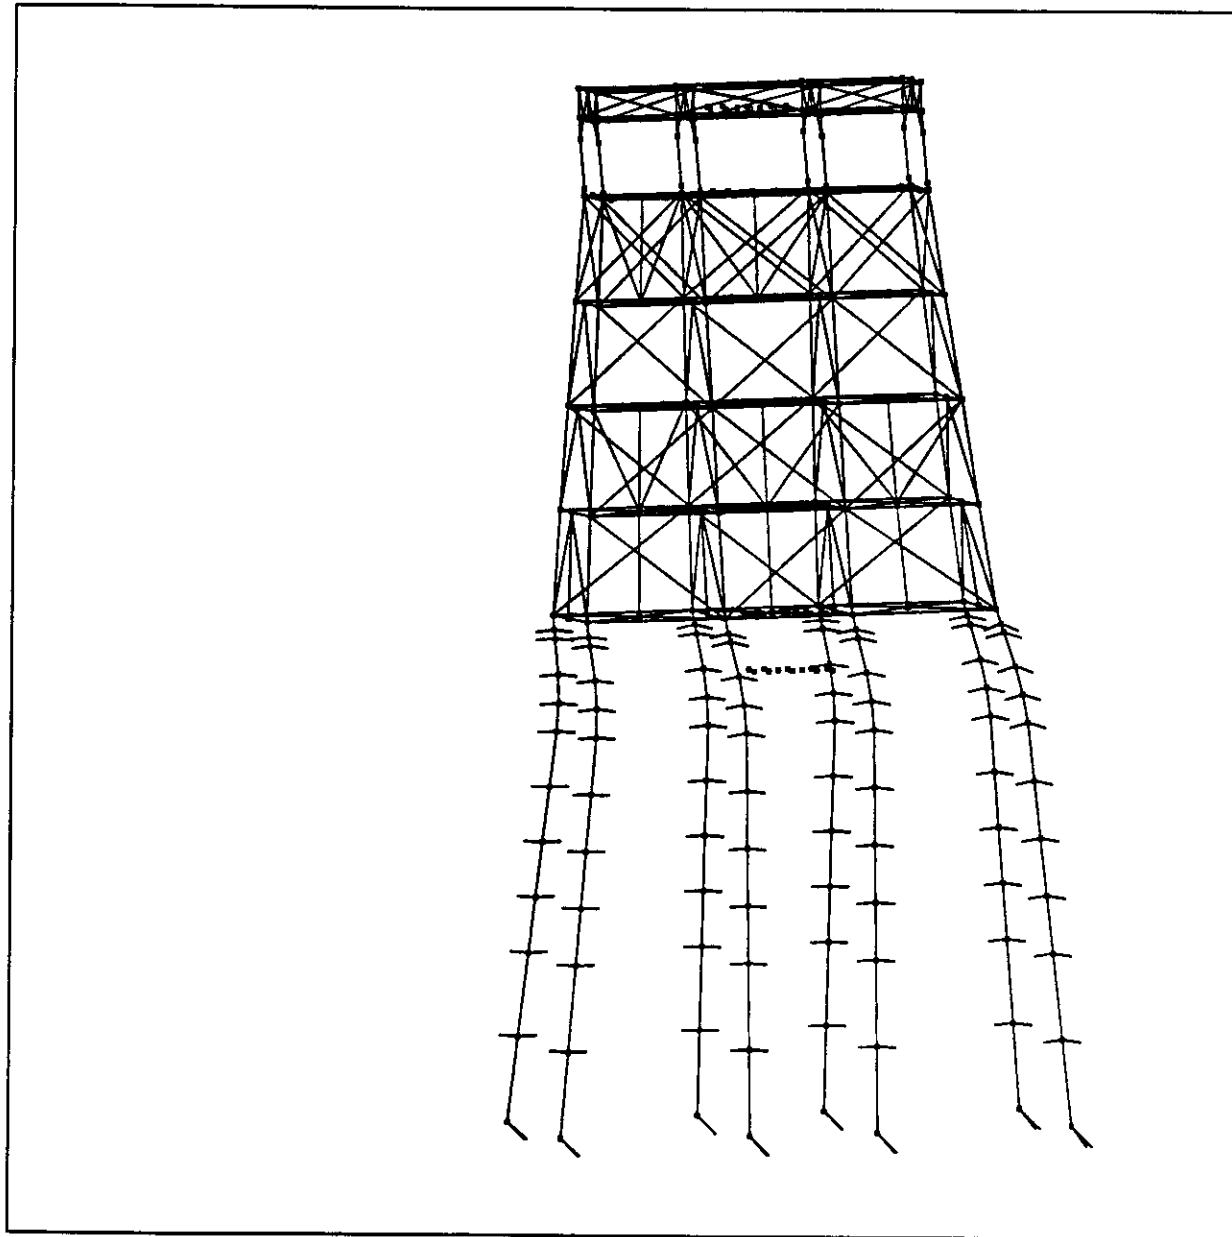
**Figure 5-3 Basic Model: Load Step at First Yield**

The capacity of the basic model is 0.66 times the Andrew environmental load. The displaced shape just prior to yield is shown in Figure 5-3. Yielded and failed elements with the corresponding displaced shapes for the last step are shown in Figure 5-4. The analysis terminated due to a large unbalance force in the piles, but it is clear that global failure would be caused by pile failure.

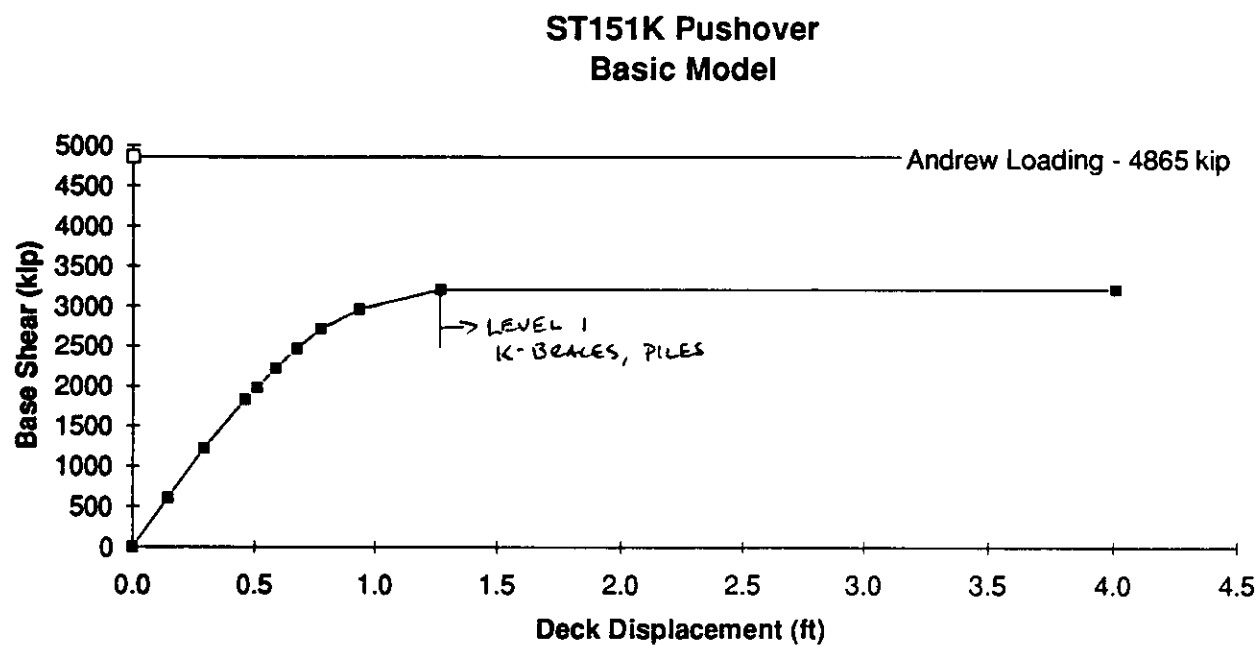
**Figure 5-5 Basic Model Results**

The pushover load plot is shown in Figure 5-5. The general behavior is a gradually, fairly smooth, decreasing stiffness, with no abrupt changes in behavior until the K-braces and piles fail. The first elements to fail are the compression K-braces in the interior bay in the first (bottom) level. This occurs at a load level of 0.66 times the total environmental load. The piles also begin to yield at a load ratio of 0.66. Although some K-braces fail, the failure mechanism for the platform is due to lateral failure of the piles.
